# Building Assessment Churchill School Galesburg, IL

City of Galesburg – Galesburg, IL

14 December 2021

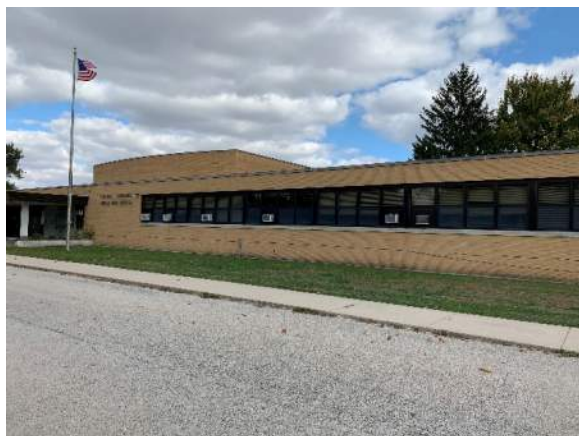
Photo A02 – West Elevation

The building observed is located at 905 Maple Avenue, Galesburg, IL (see Plan A01 and Photo A02). It is a one-story building that presently serves as a junior high school for Galesburg Community Unit School District 205. While there are multiple points of egress throughout the building perimeter, the main entry is located on the west side of the facility. Some parking is included on the north side of the property, with the main parking is located east of the building in an unmarked lot. Major amenities include classrooms/offices, cafeteria, auditorium and stage, two-court gymnasium, wood shop, and interior courtyard. The total area of the building is approximately 87,000 square feet, with the interior courtyard at just under 19,000 square feet. A dedication plaque dated the original construction in 1956. A schematic floor plan of the building is provided at the end of this report for reference.

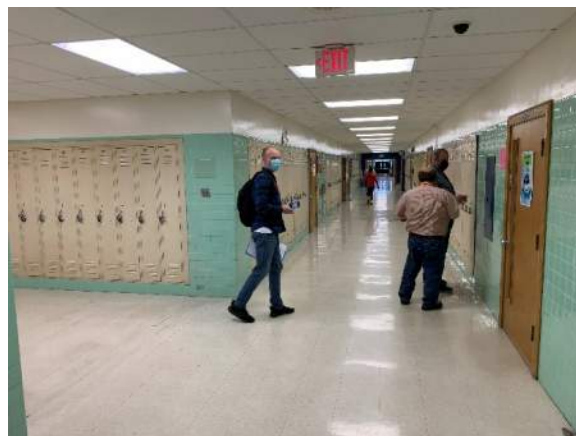
Photo A03 – Typical Corridor

Multiple points of egress were noted in the existing building, so overall egress lengths from the building does not seem to be an issue. However, one area of concern is the apparent lack of fire-rating at the main corridors throughout the entire building (see Photo 03). This was further evidenced by the lack of rated openings, including door grills (see Photo A04). Current use group standards withstanding, corridors would need to have a 1-hour fire-resistance rating due to the building being unsprinklered. While most doors appear to be solid core and may attain the required fire rating, those doors with large openings/grills would need to be replaced.

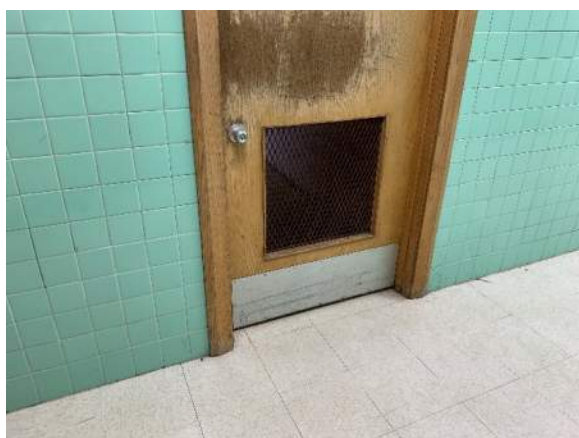
Photo A04 – Corridor Door w/ Grill

| ▪ Fire Rated Door Replacement (at Corridor) | \$70,000 |

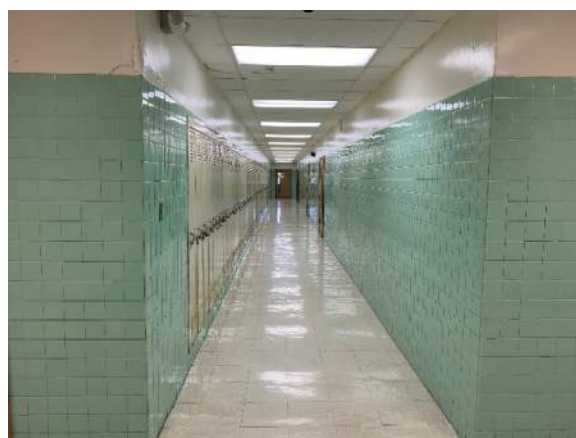
Another area of concern is the hallway adjacent to the east side of the gymnasium (see Photo A05). The north end of this corridor did not continue to an exit or exit access, and in its current state exhibits a dead-end corridor. The allowable distance for this condition is 20'-0" or less, while the actual distance is nearly 80'-0". It is recommended that the renovation provide exit access at this location in particular.

Photo A05 – Dead End Corridor

| ▪ Egress to Exit (Dead End Corridor) | \$20,000 |

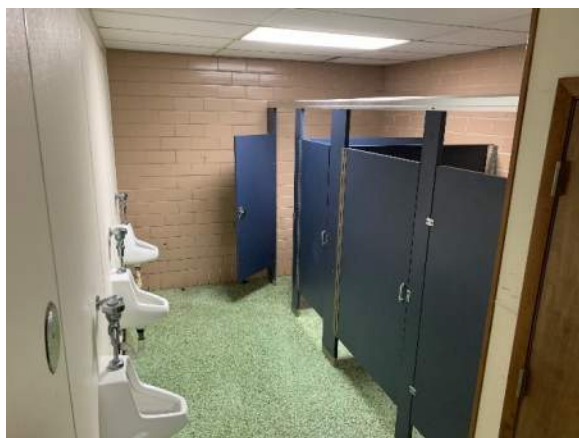
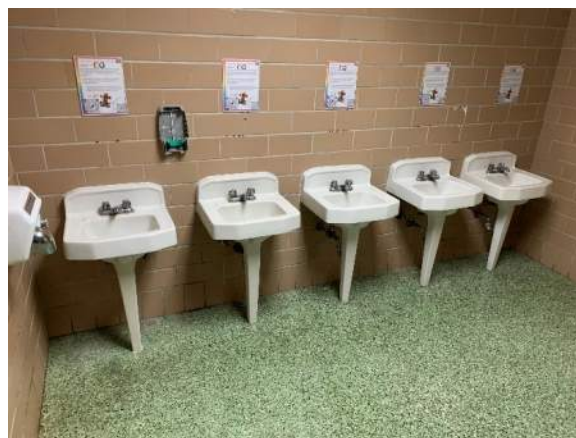
While minor issues regarding Illinois ADA were noted throughout the facility, most of them are related to the lack of compliant restrooms. There is a pair of fully compliant restrooms centrally located near the boiler room, but the rest of the restrooms do not adhere to current standards. These issues include existing door clearances, wheelchair turning clearances, and bathroom accessory mounting criteria (see Photos A06 and A07). These areas should be addressed upon renovation.

Photo A06 – Typical Restroom

Photo A07 – Typical Restroom

| ▪ ADA Compliant Restrooms/Locker Rooms | \$160,000 |

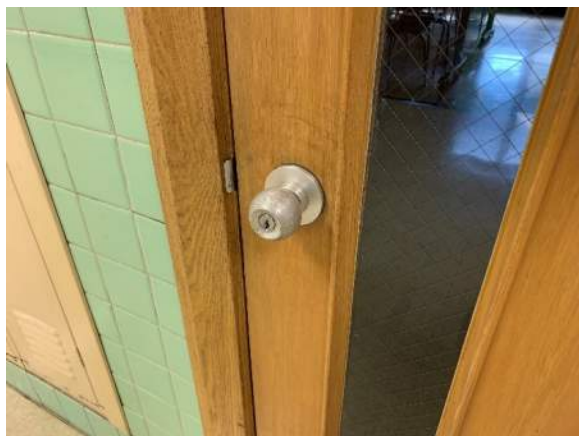
An additional issue regarding accessibility was the door handles typically found throughout the building. While the main egress doors exhibited lever operation, the typical door hardware at classrooms and offices utilized doorknobs (see Photo A08). Per Section 309.4 of 2018 Illinois Accessibility Code, "Operable parts shall be operable with one hand and shall not require tight grasping, pinching, or twisting of the wrist". This hardware would need to be replaced as the renovation progresses.

Photo A08 – Non-compliant Door Handle

| ▪ Door Hardware Replacement | \$65,000 |

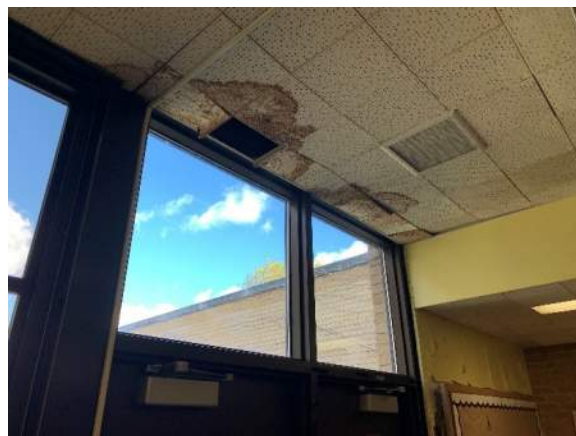
Some evidence of past water intrusion was observed in the building, most notably in the library area (see Photo A09). While the ceiling panels have not been replaced, the damage does not appear to be recent, and it is assumed that the intrusion has been abated. It was also mentioned that there was a recent roof leak at the north side of the gym (see Photos A10 and A11). Upon discussion, this repair has already taken place, and there was not further issue at the time of this report.

Photo A09 – Water Intrusion Damage

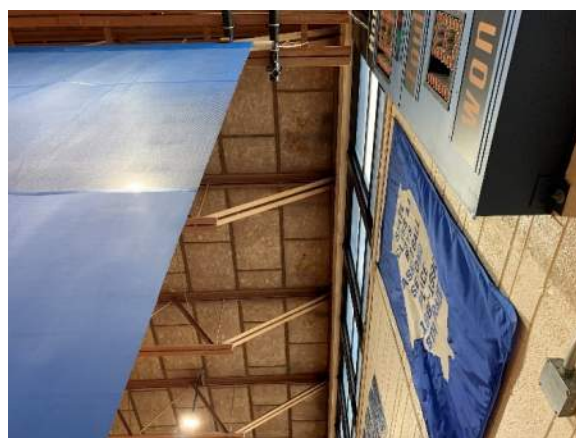
Exterior finishes of the building are relatively good condition. The aluminum storefront strip windows predominately around the building do show some signs of wear, but most of the seals appear to be in fair condition. It appears that these windows would not require replacement for another 10 years, although some screens are torn and may necessitate replacement.

Photo A11 – Water Intrusion (Gym)

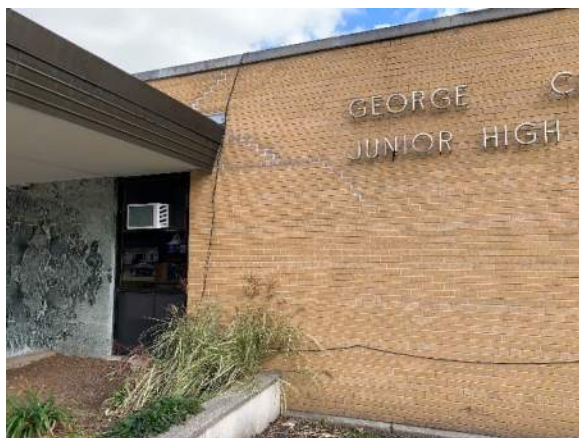
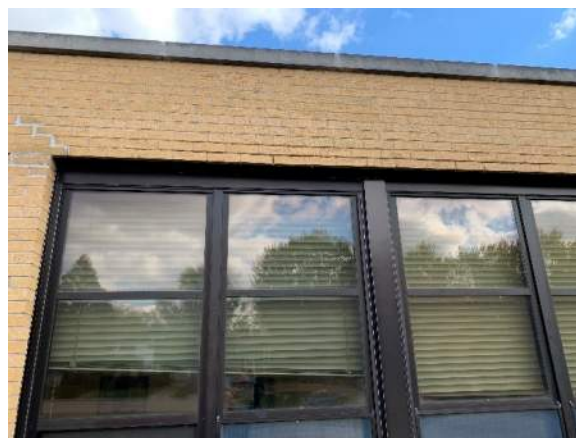
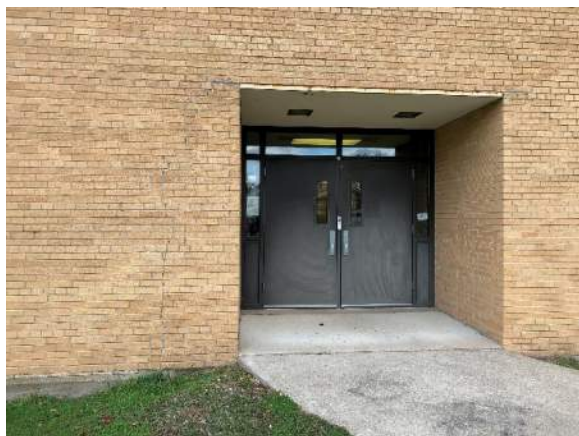
The brick veneer is also in good condition for a building of this age. Certain areas, however, require tuckpointing and minor repair in order to maintain the building envelope (see Photos A12 – A14). The boiler chimney in particular needs immediate repair (see Photo A15). Other areas indicating sealant in lieu of mortar should also be addressed in the various repair. Past repair and/or brick replacement was noted at the northwest corner of the building.

Photo A12 – Tuckpointing at West Elevation

Photo A13 – Tuckpointing, Typical

Photo A14 – Masonry Repair, East Elevation

| ▪ Miscellaneous Tuckpointing | \$195,000 |

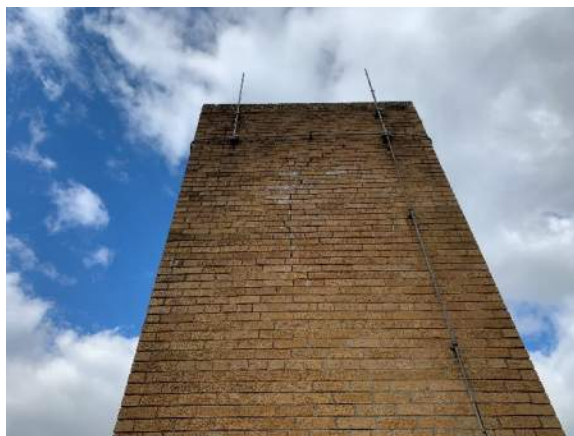
Photo A15 – Masonry Repair, Chimney

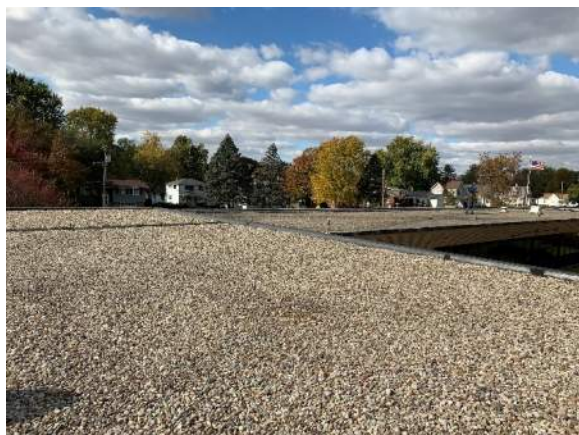
As previously mentioned, a portion of the ballasted EPDM roof system was recently replaced at the south side of the building (see Photo A16). The remainder of the roofing at the lower areas appears to be in fair condition, although a more in-depth analysis may be required (i.e., due to the ballast covering the membrane). The high roof of the gymnasium/auditorium seems to exhibit more wear and warrants replacing in the next 5 years (see Photo A17). The age of the older roof was not determined, although the lifetime of similar systems may be 20-25 years. Expansion joints separating the various wings of the building were found to be in good condition. A portion of the coping and roof edge appeared to have been recently repaired at the area of the roof leak at the gym. Please note that proposed roof work would also include coping repair/replacement and miscellaneous flashing.

Photo A16 – New/Old Roof (Lower)

| ▪ Partial Re-Roof (not including South Wing) | \$810,000 |

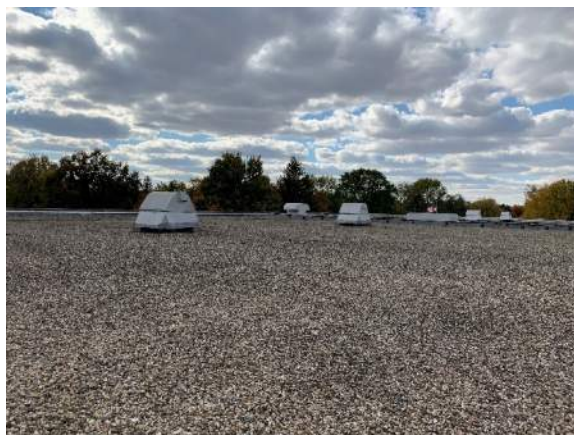
Photo A17 – Gymnasium Roof (Upper)

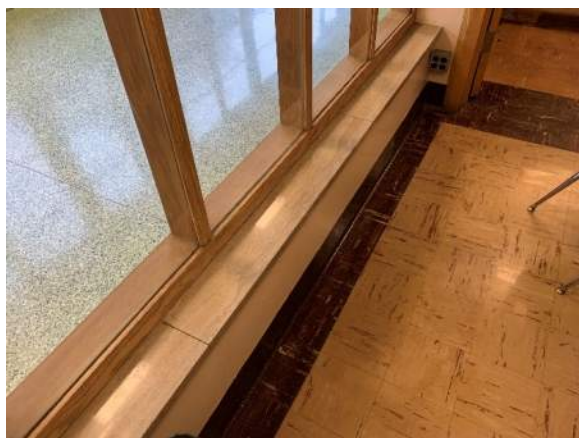
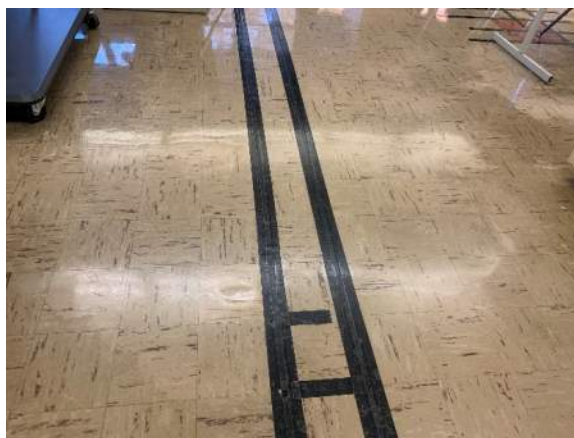
Interior finishes vary greatly throughout the facility. Floor finishes include terrazzo, ceramic tile, vinyl tile, carpeting, exposed concrete, and apparent asbestos tile (see Photos A18 and A19). Wall finishes observed were painted plaster, ceramic wall tile, painted gyp. board, glazed block, brick, and painted CMU. Ceiling finishes consist of suspended acoustical ceiling panels, tectum panels (at the gym), plaster (at the auditorium), and apparent direct applied asbestos ceiling tile (see Photo A20).

Hazardous material is expected in some of the finishes found throughout the building. These include asbestos floor and ceiling tile, as well as potential lead paint (see Photo A21). While the tile may be left in place and covered over (as applicable to manufacturer's recommendations), the paint may need to be abated. It appears that at least some abatement will be required due to failing floor/ceiling tiles. It is highly recommended that these materials be tested for confirmation.

Photo A18 – Terrazzo & Asbestos Floor Tile

Photo A19 – Asbestos Floor Tile

An outlying factor is addressing the hazardous material as previously mentioned. It is recommended that, when possible, the floor/ceiling tile be left in place and covered with an appropriate finish. In this way the renovation may be economically provided without the need for full abatement.

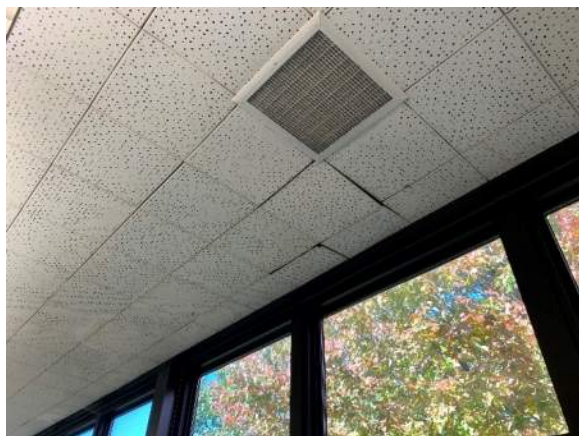
Photo A20 – Asbestos Ceiling Tile

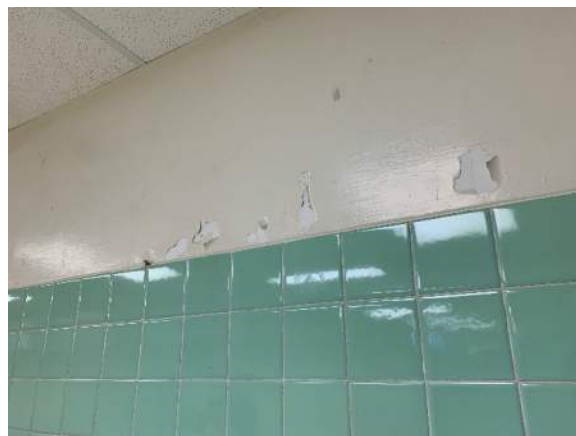
Photo A21 – Painted Finish (at Corridor)

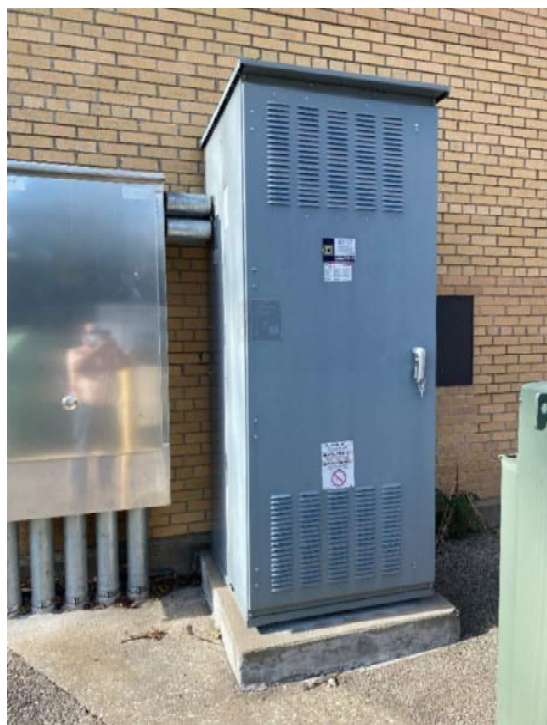
Photo E01 – Service Entry Switch

Regarding Power, the existing service entrance equipment was replaced in recent years and includes a 1600-amp 120/208-volt 3 phase 4 wire service entrance switch located exterior and in the rear of the building. Ameren reports a peak demand on the service of 70 kVA (194 amps) Fed from a 300 kVA transformer. This allows for the 230 kVA (638 amps) spare capacity for future work. This switch is in great shape and has many years of service life available (see Photo E01).

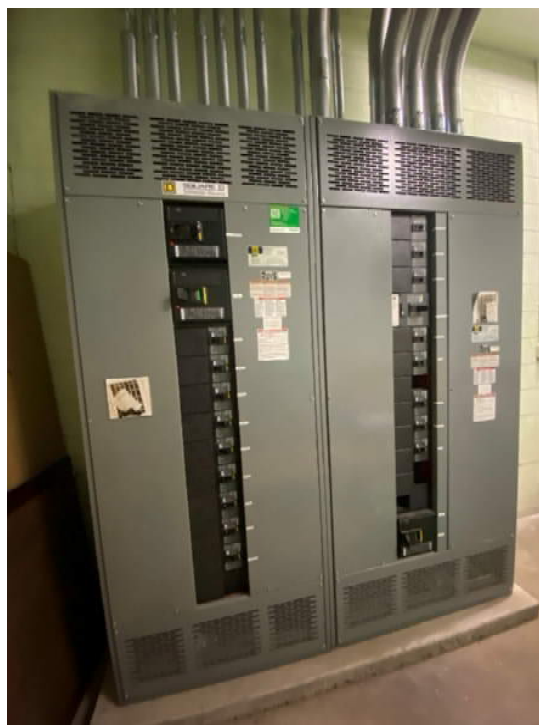
Photo E02 – Main Distribution Panel

The service entrance switch feeds a 1600-amp main distribution board (MDP) in the lower-level electrical room (within the boiler room). The MDP is of the same age as the service entrance switch and is also in great shape (see Photo E02).

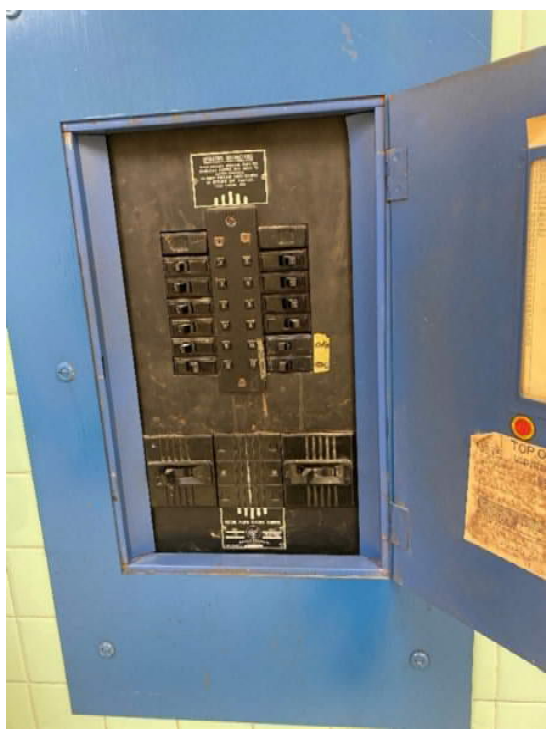
Photo E03 – Branch Circuit Boards

There are several branch circuit panel boards throughout the facility, these however are part of the original building construction (circa 1975) and have met their expected service life. The manufacturer is

no longer in business and replacement parts are extremely hard to find, and if found are salvaged material and not reliable (see Photo E03 for typical panel).

Replace all branch circuit boards in the facility.

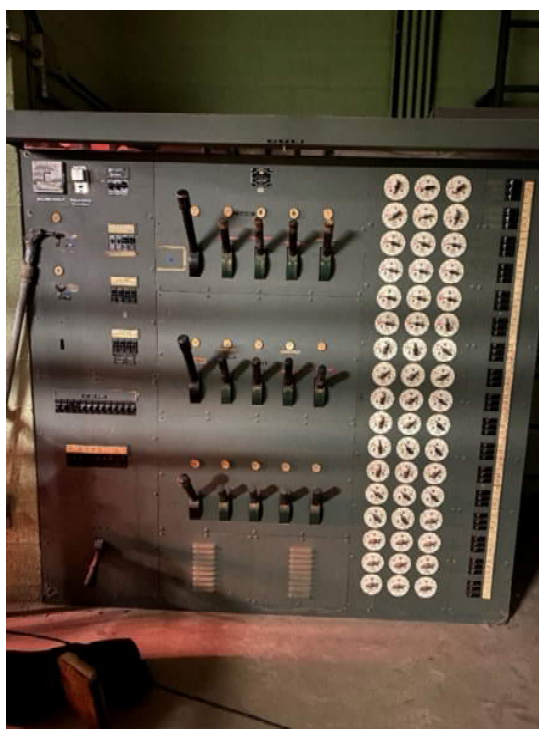
Photo E04 – Theatric Lighting System

The Auditorium has a 50+ year theatric dimming system that has met its end of useful life (see Photo E04).
